Water on the wrong side of the levee?

Snohomish County, WA - Severe flooding in western Washington State in early January 2009, brought on by heavy rainfall and warm temperatures that melted December's snow, posed the first test for the flood drainage gates installed 15 months earlier in the levee along the lower Stillaguamish River ("Old Stilly") south of Stanwood. The floodgates passed that test with "flying colors," according to Max Albert of the Stillaguamish Flood Control District (SFCD). Albert was referring to how quickly – in about half the time as during previous floods – that floodwaters trapped behind the levee drained through the gates and off Marine Drive and the Burlington Northern Santa Fe (BNSF) railroad tracks.

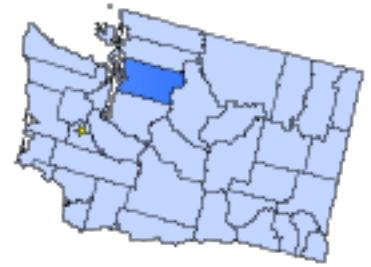
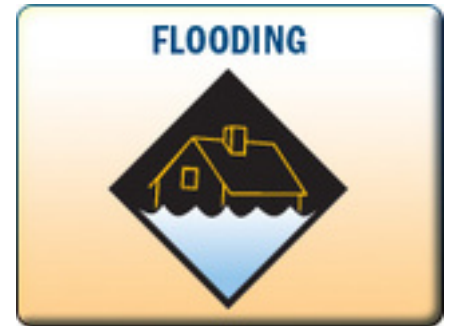
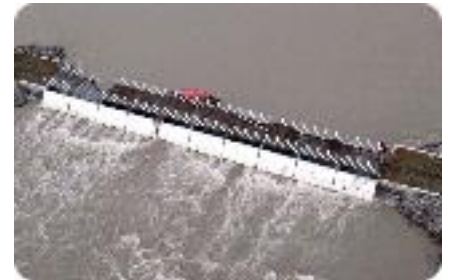
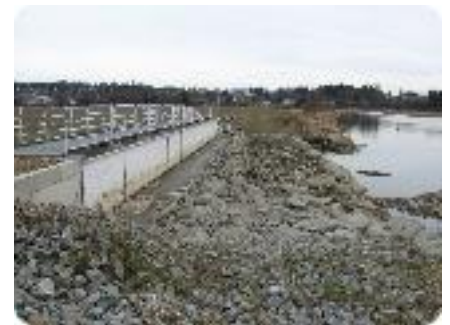
The SFCD, which maintains the levees and drainage systems in a 6,000-acre area of the lower valley between Silvana and Stanwood, was formed in 1992. In 2005, in an effort to eliminate or at least lessen the effects of future floods, the SFCD proposed construction of a flood drainage gate in the existing levee of the Stillaguamish River Old Channel near Stanwood. With a grant from the Federal Emergency Management Agency (FEMA), \$30,000 from the City of Stanwood, and technical assistance from Snohomish County, the SFCD built the "Old Stilly Gate" in September 2007. The "gate" consists of a 130-foot-long concrete section, with 10, 5-foot by 10-foot, top-hinged hatches installed within the levee. A riprap (large angular rock) apron protects the levee bank on the discharge (river) side. The floodgate is self-actuating: If the water level behind the levee is higher than the river, the hatches open and water drains to the river. If the river is higher than the water behind the levee, the hatches close to prevent flooding from the river.
